**ELECTRONICS COORDINATING OF**  
**SHIP PREPARATION**  
**and**  
**TARGET INSPECTION**

**FINAL REPORT**  
**TESTS ABLE AND BAKER**

**VOLUME 2**  
**PHOTOGRAPHIC RECORD**

**DIRECTOR OF SHIP MATERIAL**  
**JOINT TASK FORCE ONE**  
**OPERATION CROSSROADS**

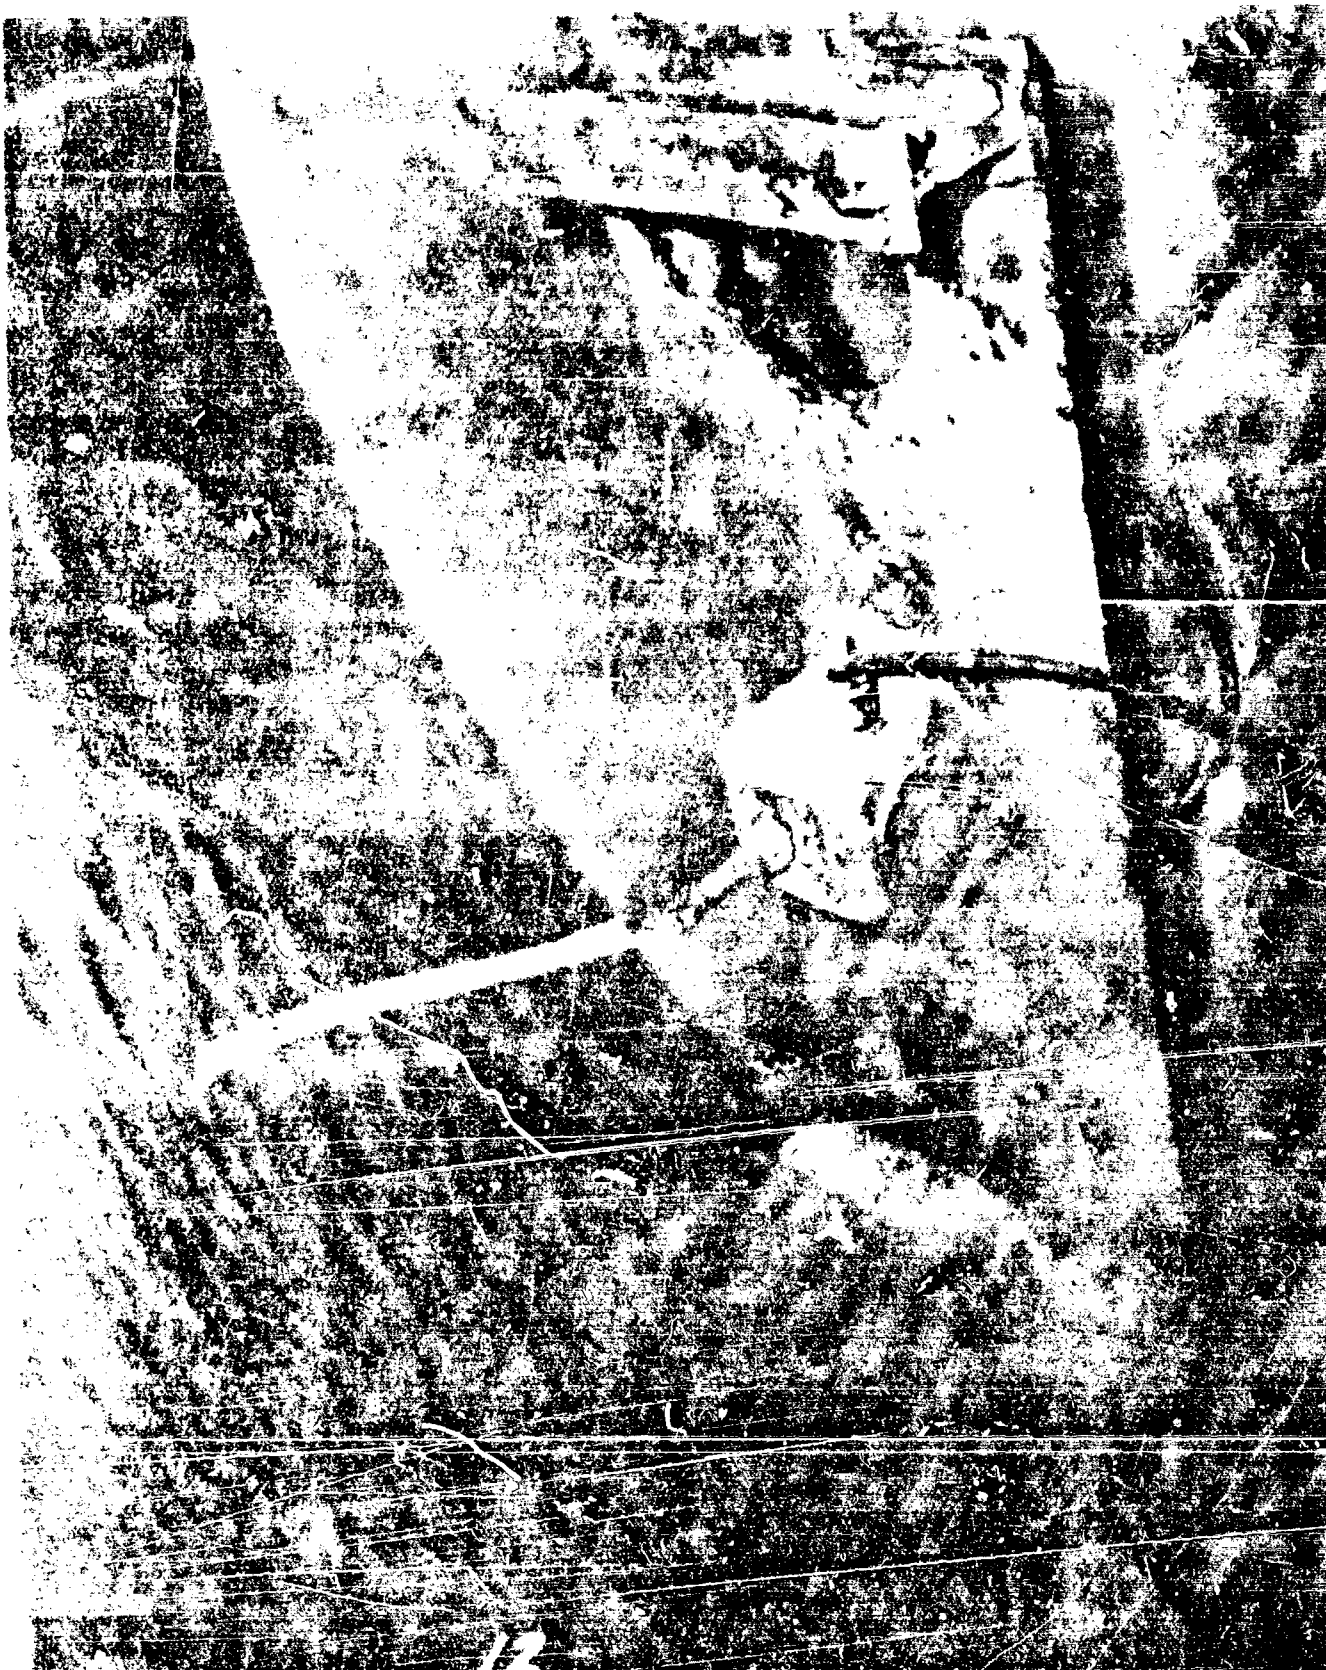
POST ABLE - MK 3 RADAR ANTENNA. Supporting framework failed completely as blast blew antenna from mount.

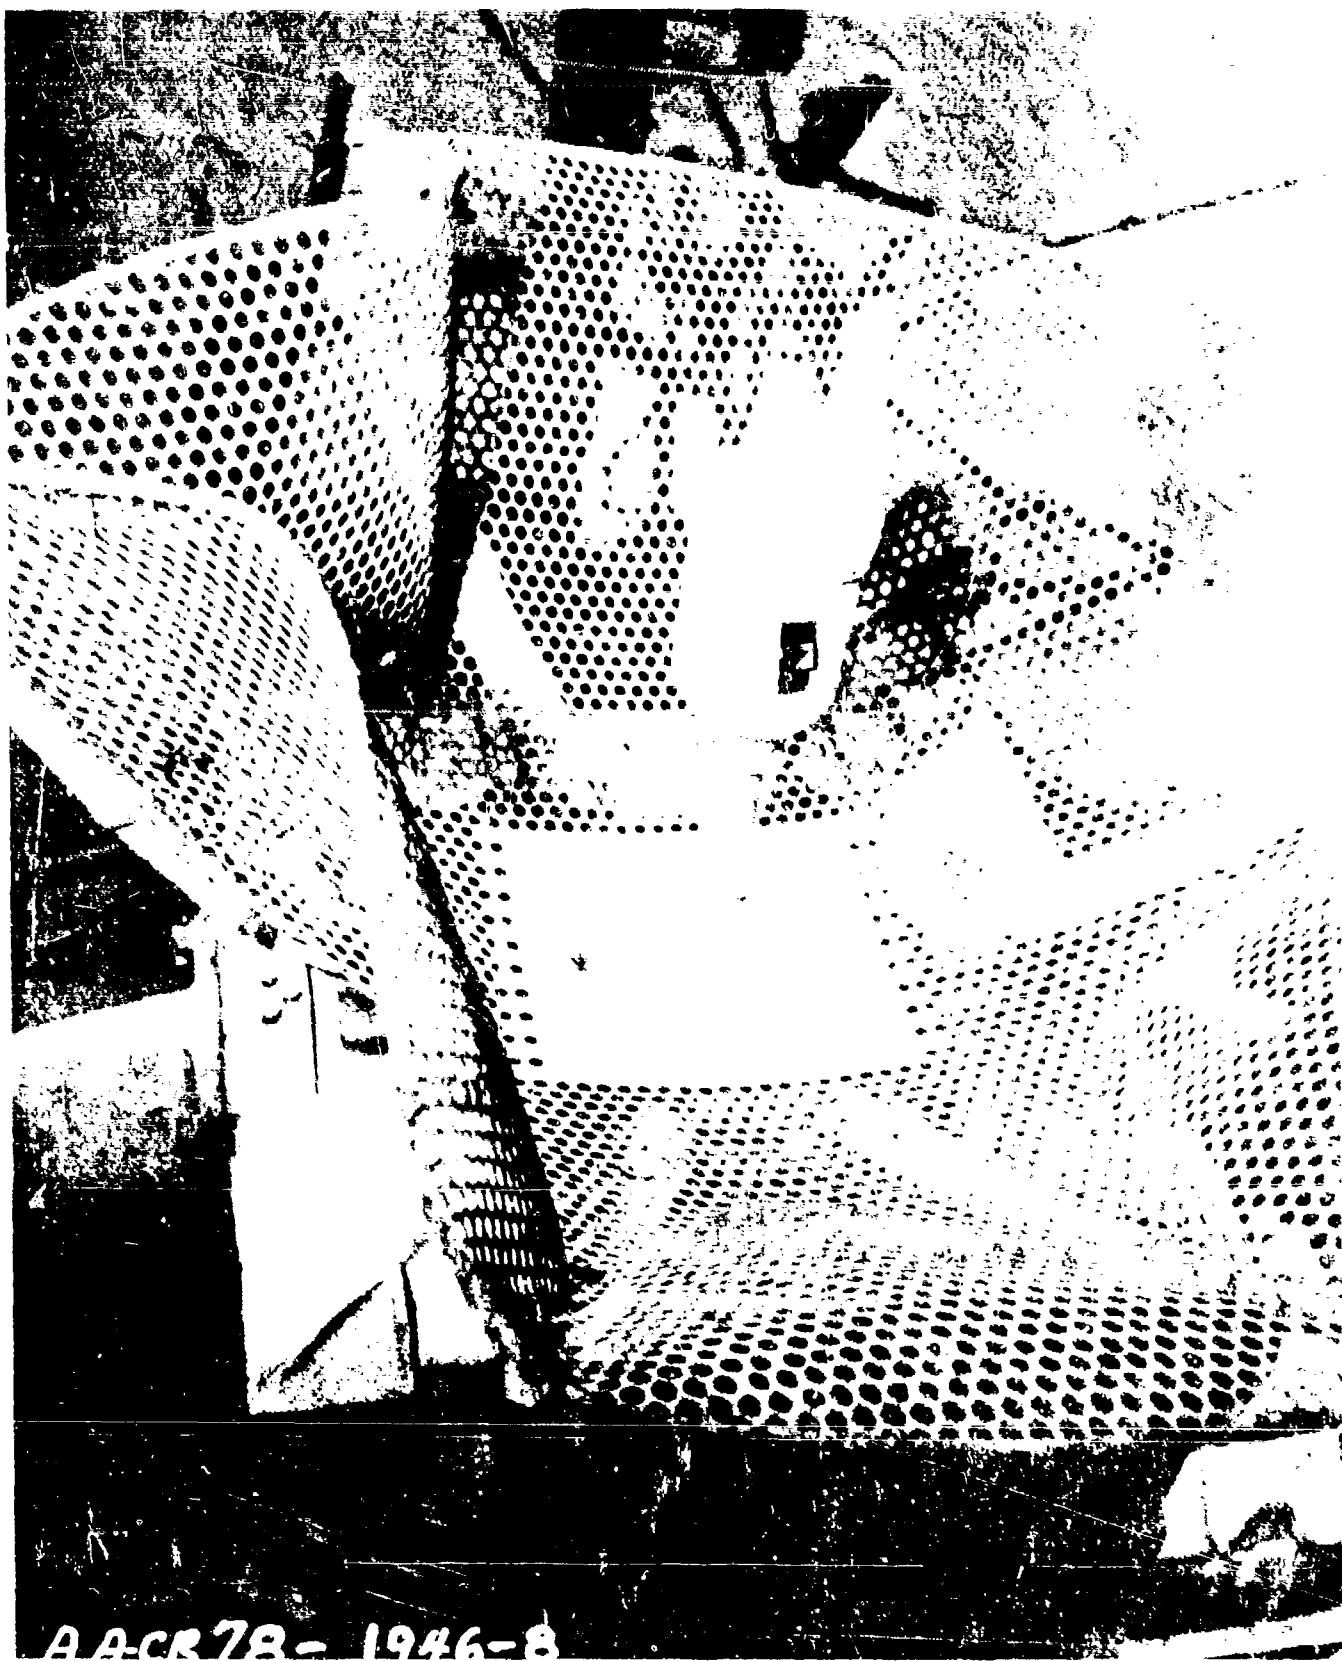
POST ABLE - MK 28 ANTENNA. Main battery forward. Parabola and one or two supports would have to be replaced.

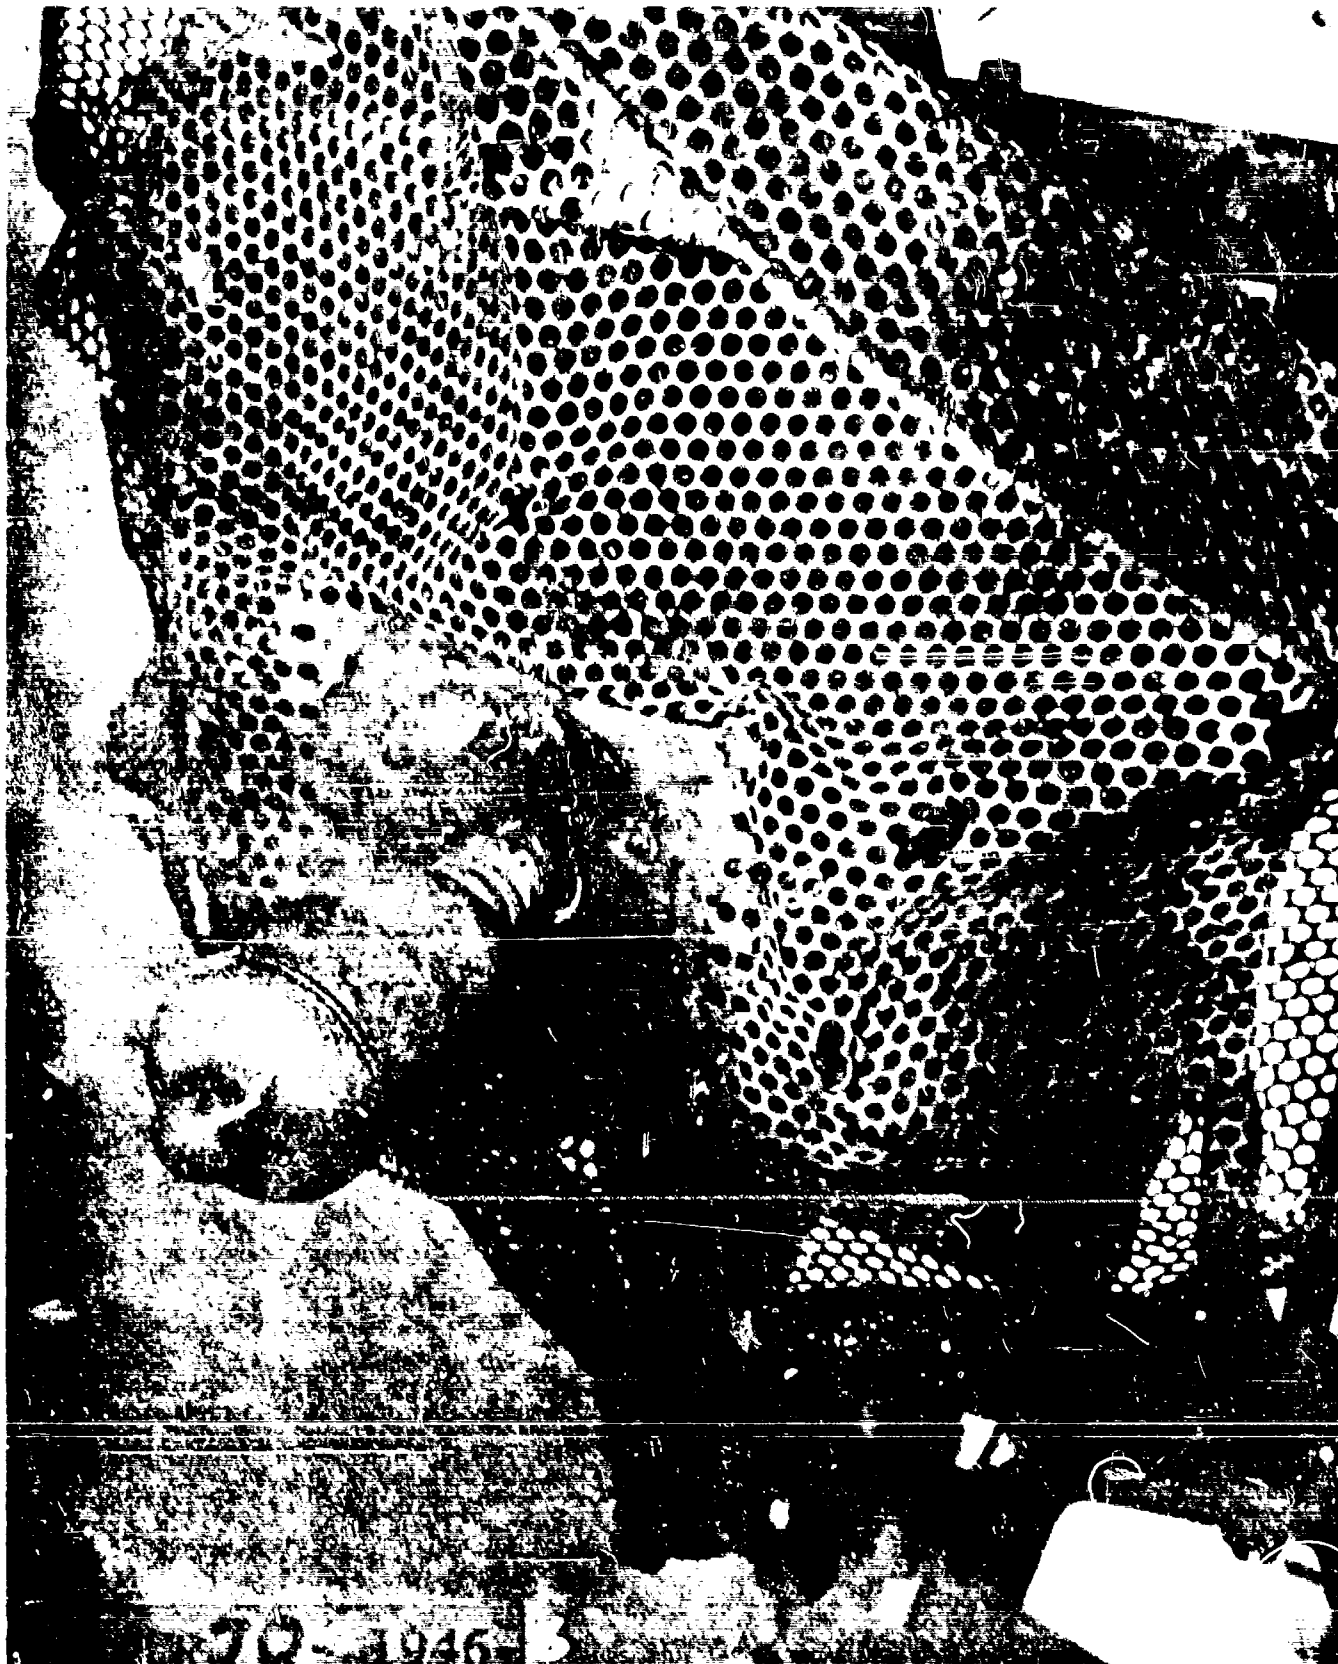
POST ABLE - MK 28 ANTENNA. Main battery director aft. Parabola and supports were badly damaged. Polyethylene dipole cover was burned by heat from radiation. Cables to transmitter were also charred slightly.

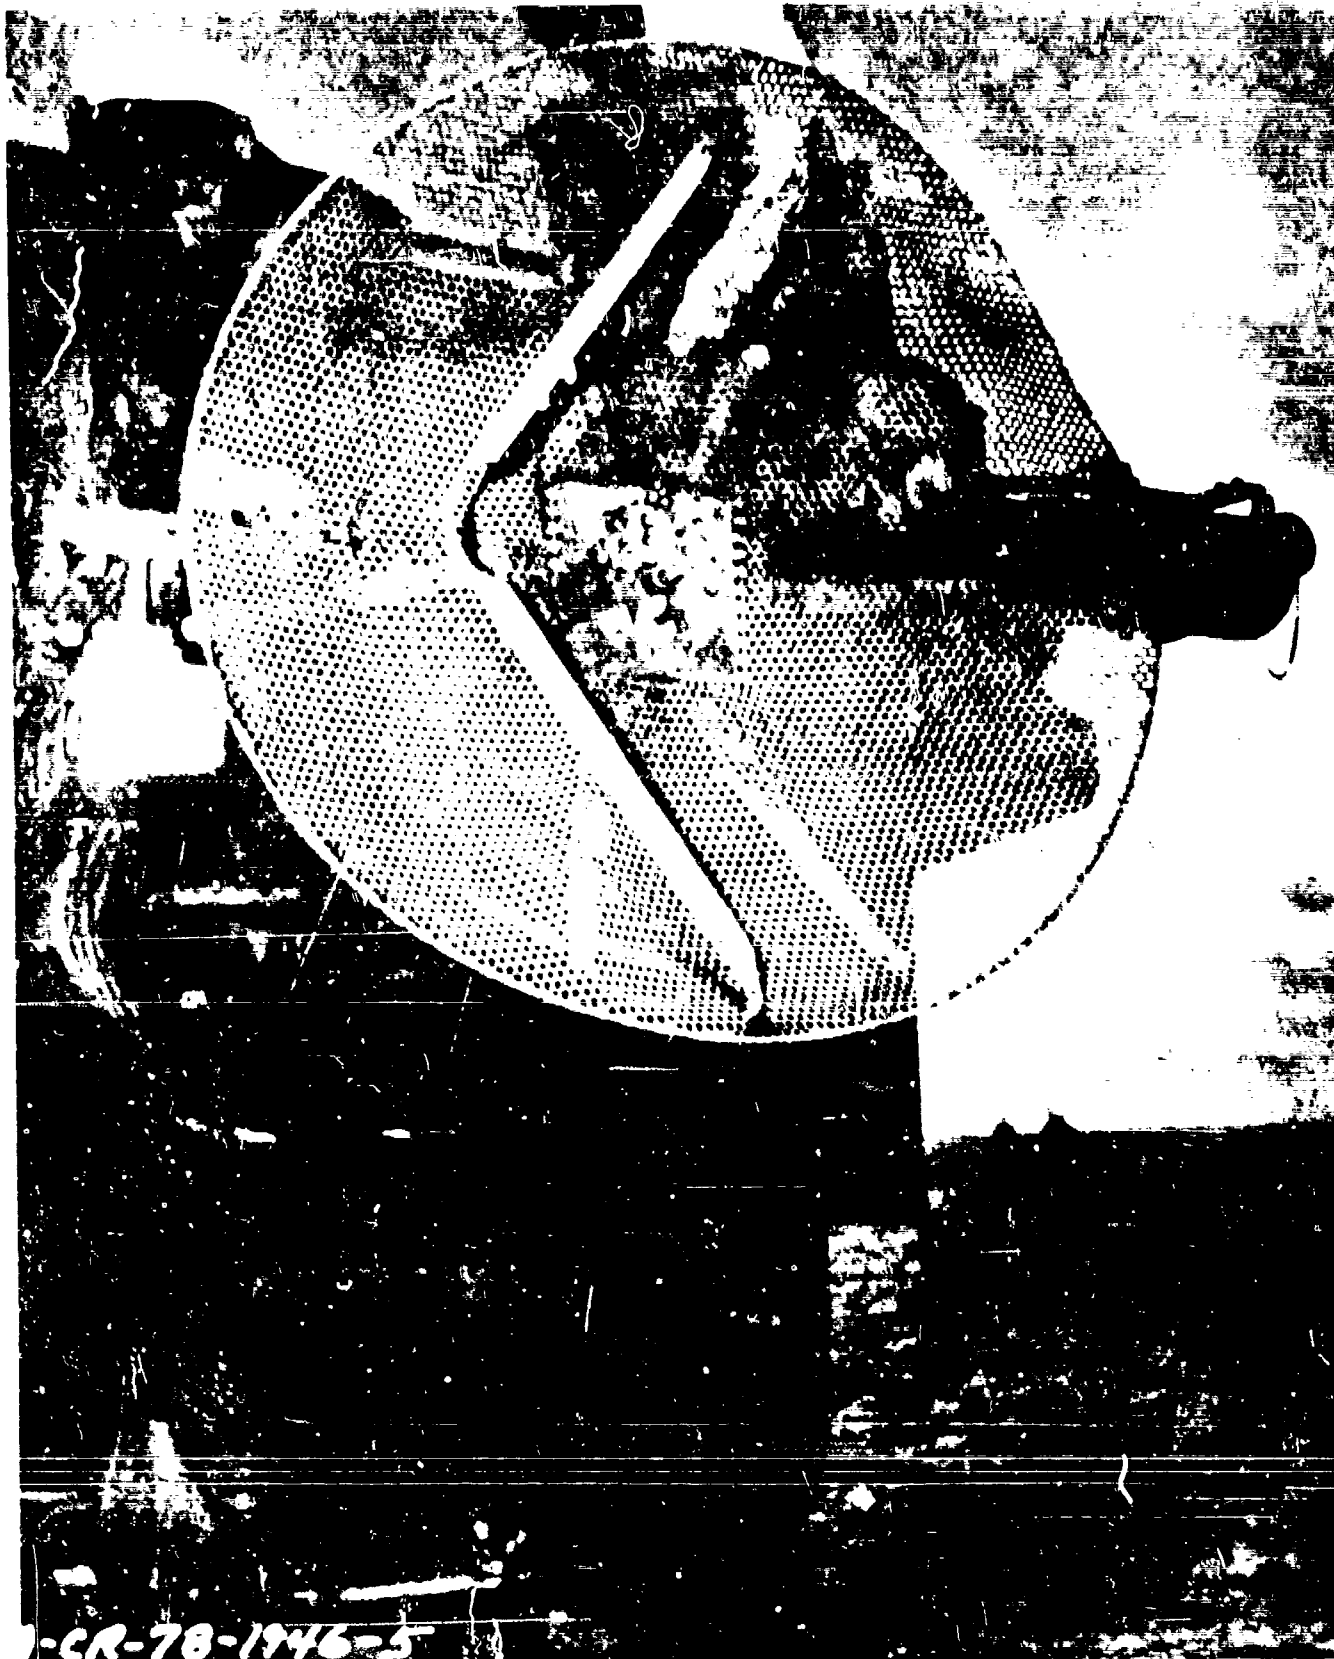
POST ABLE - MK 28 MOD 3 RADAR. AA director aft. Radar was operating into dummy load during test. Dummy load was blown off at "C" and was found lying on deck. Support "A" was used to help hold the dummy load. Parabola was slightly bent and would have to be replaced.

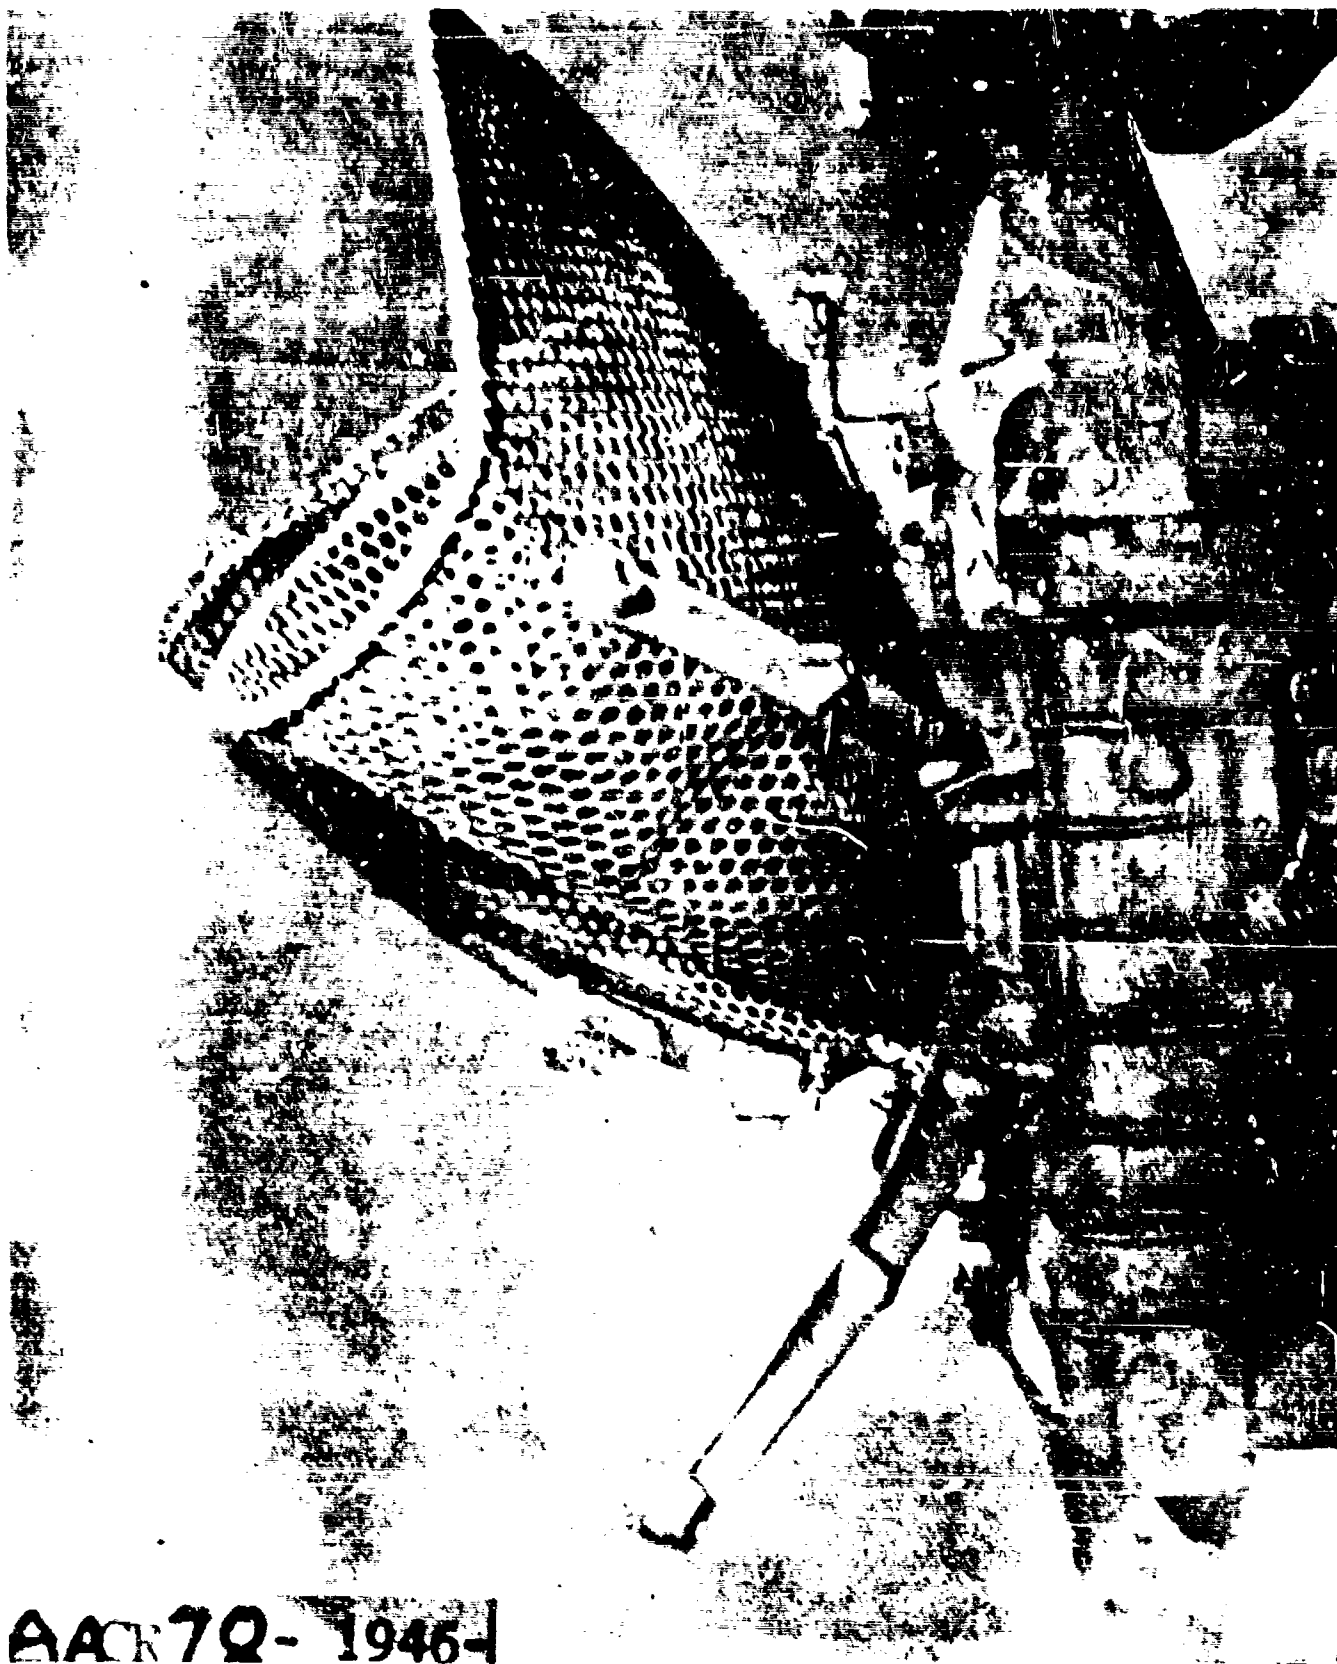
POST ABLE - MK 28 ANTENNA. Forward AA fire control antenna. Broken parabola support "A" is shown. Parabola, parabola support, and dipole assembly would all have to be replaced to restore operation.

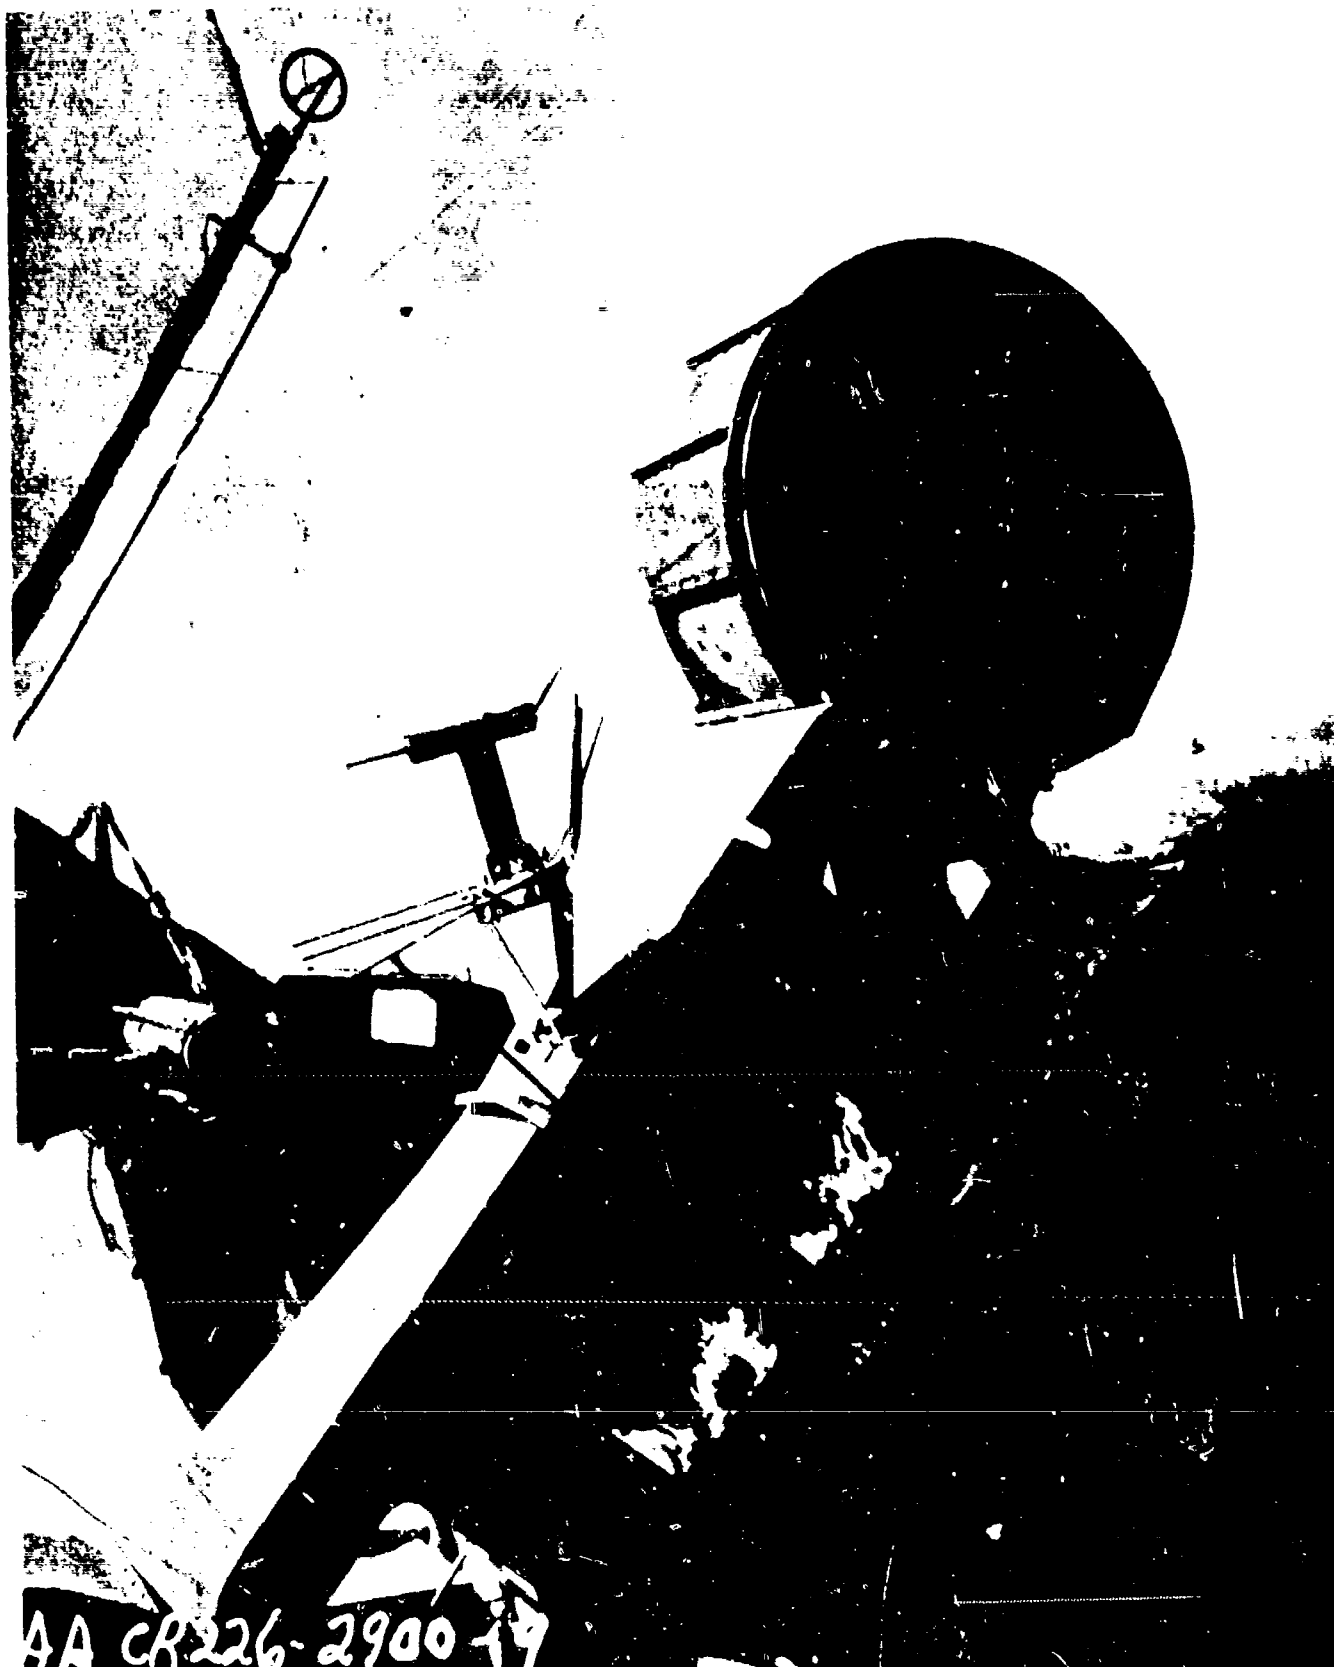
POSTABLE - TDM ANTENNA. Damaged antenna (See arrow).

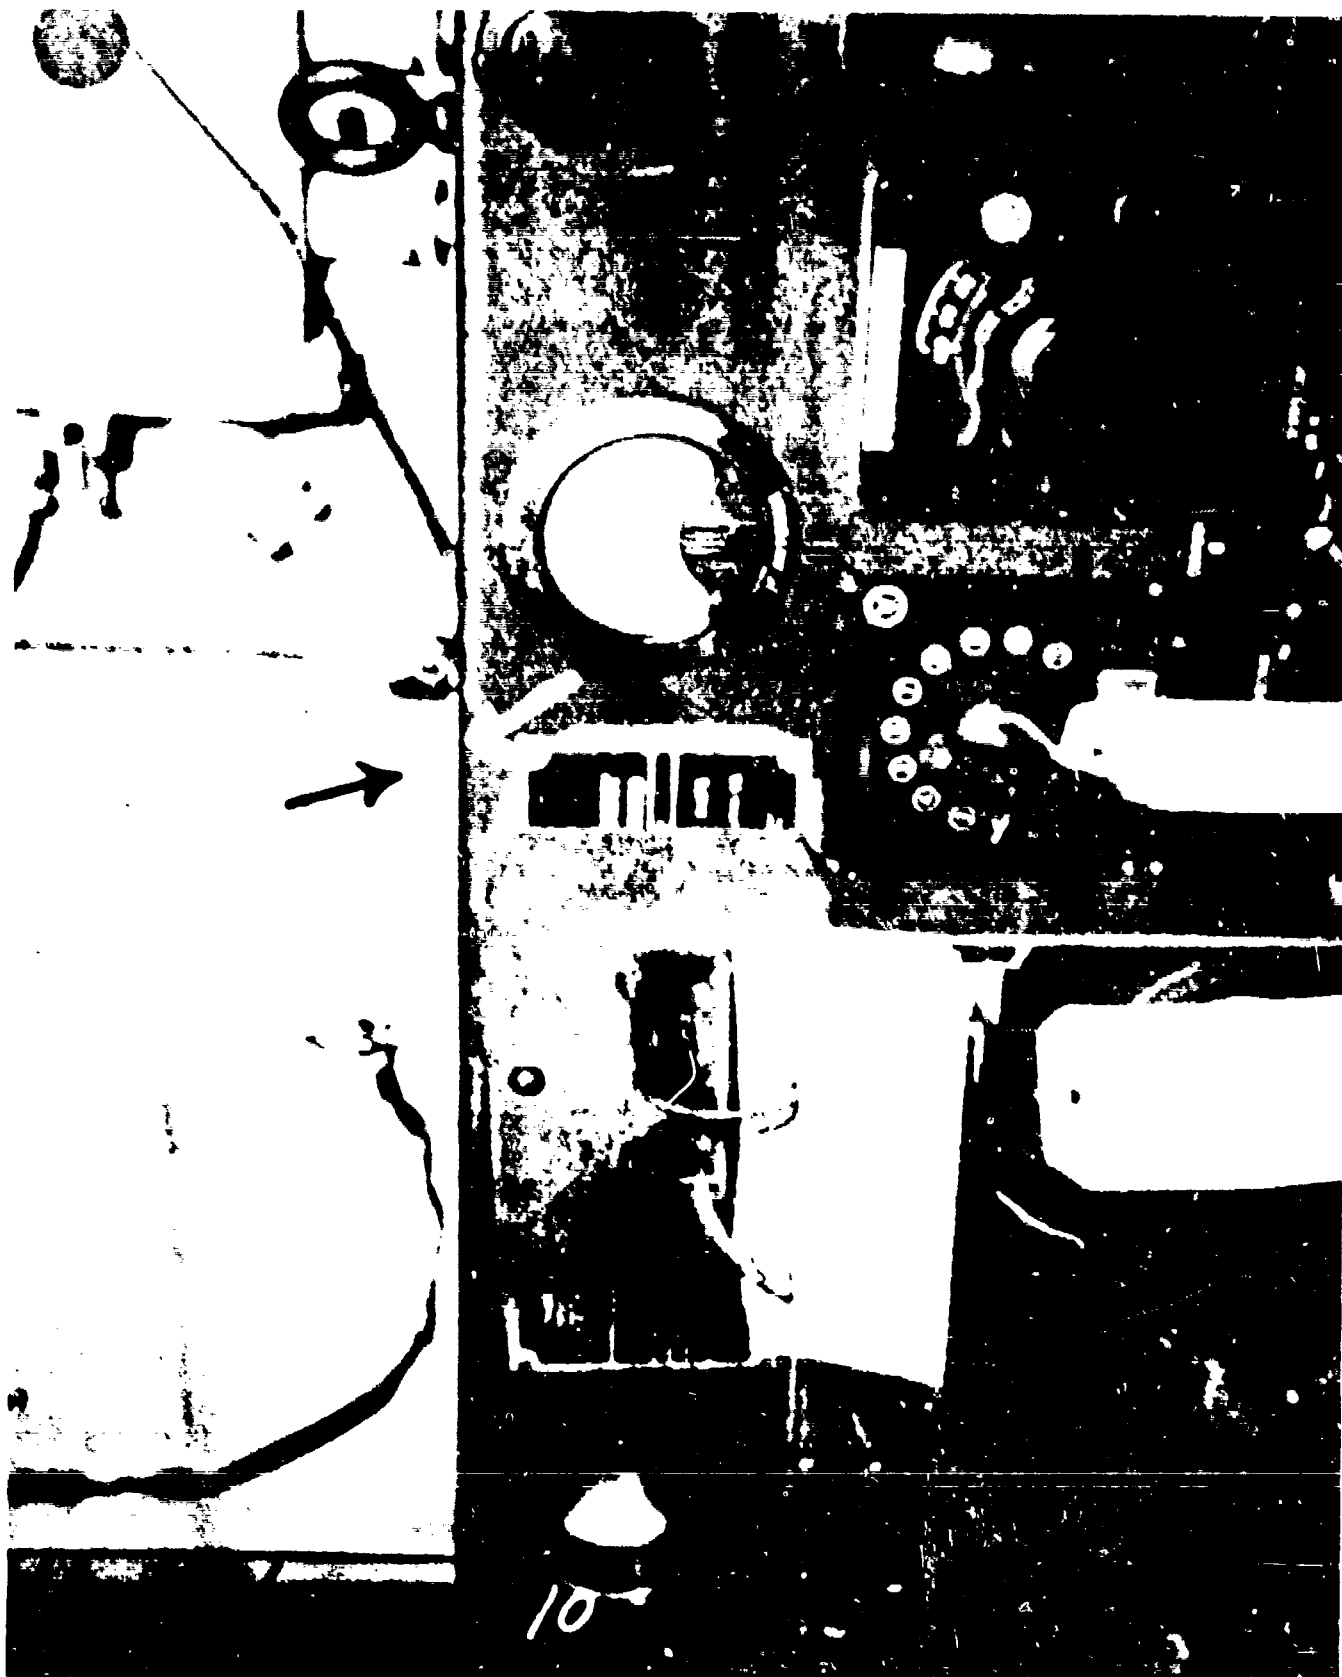
POST ABLE - TEE. Antenna lead-in insulator was broken (See arrow).

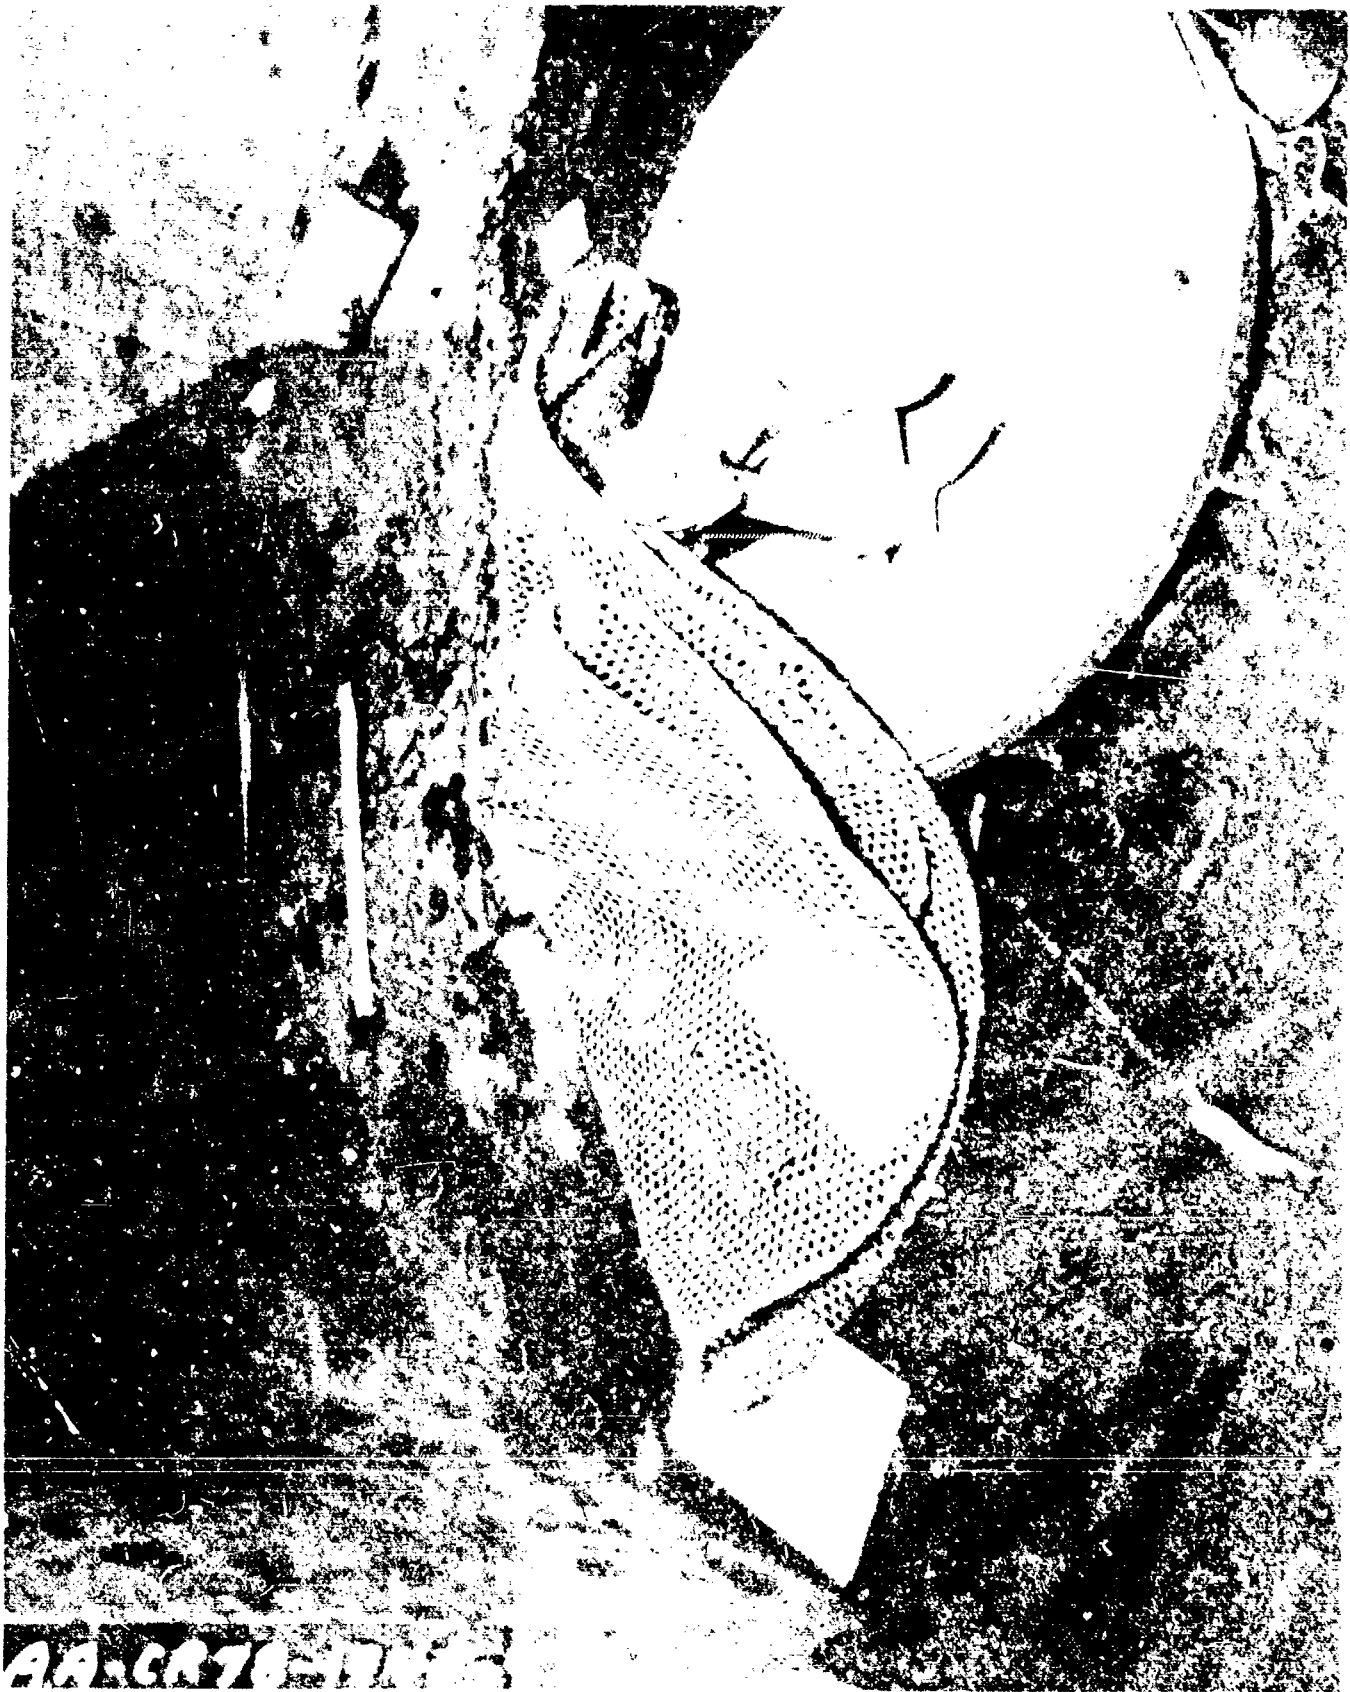
POST ABLE - MK 28 ANTENNA. MK 28 antenna as found on deck after test.

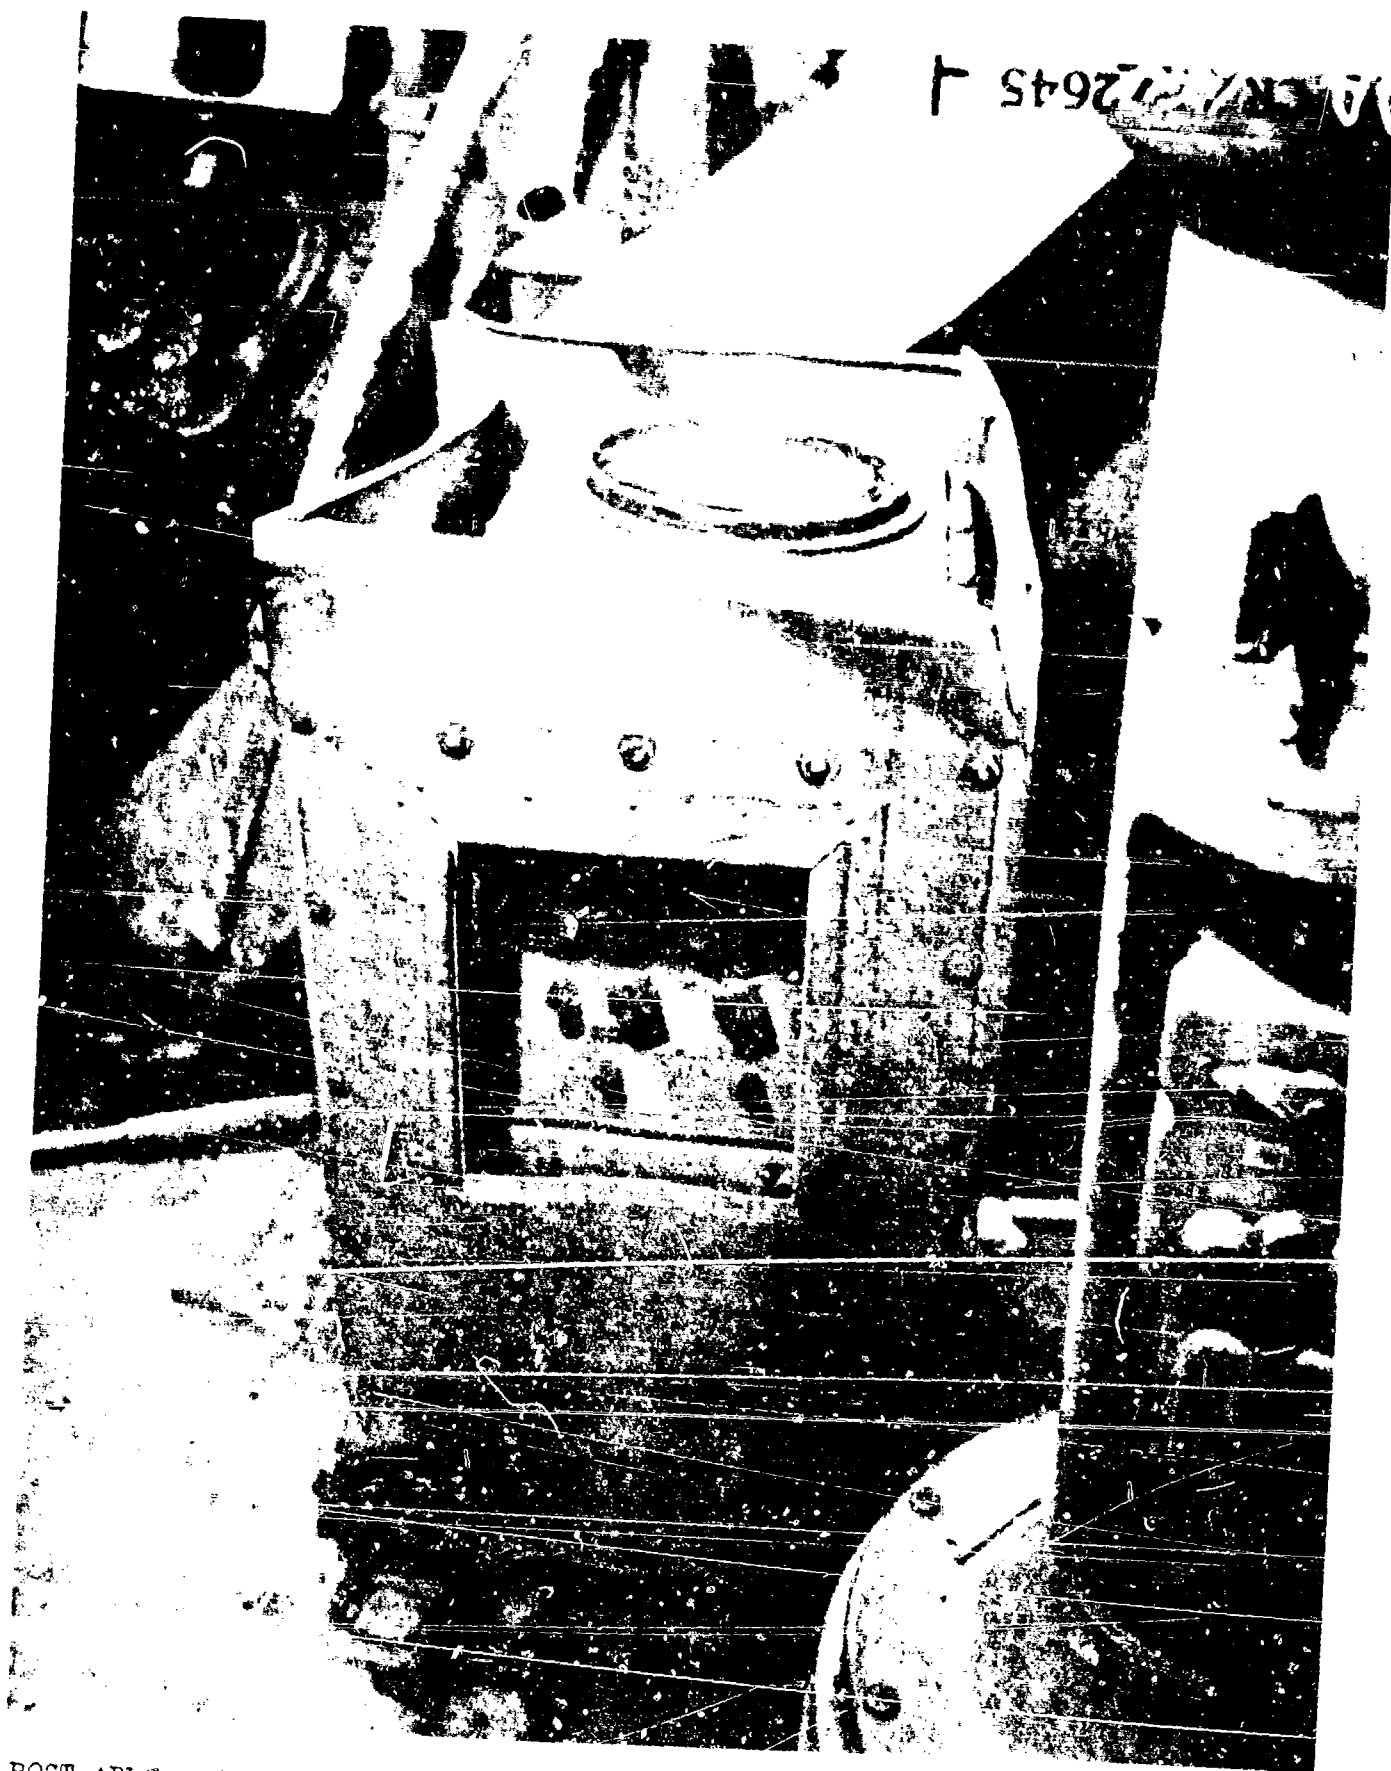
POST ABLE - VD-2 Equipment on open bridge. Welds parted on foundations, and subsequent movement of VD-2 parted cables. Housing sides were warped and top blown off, but VD-2 was apparently undamaged.

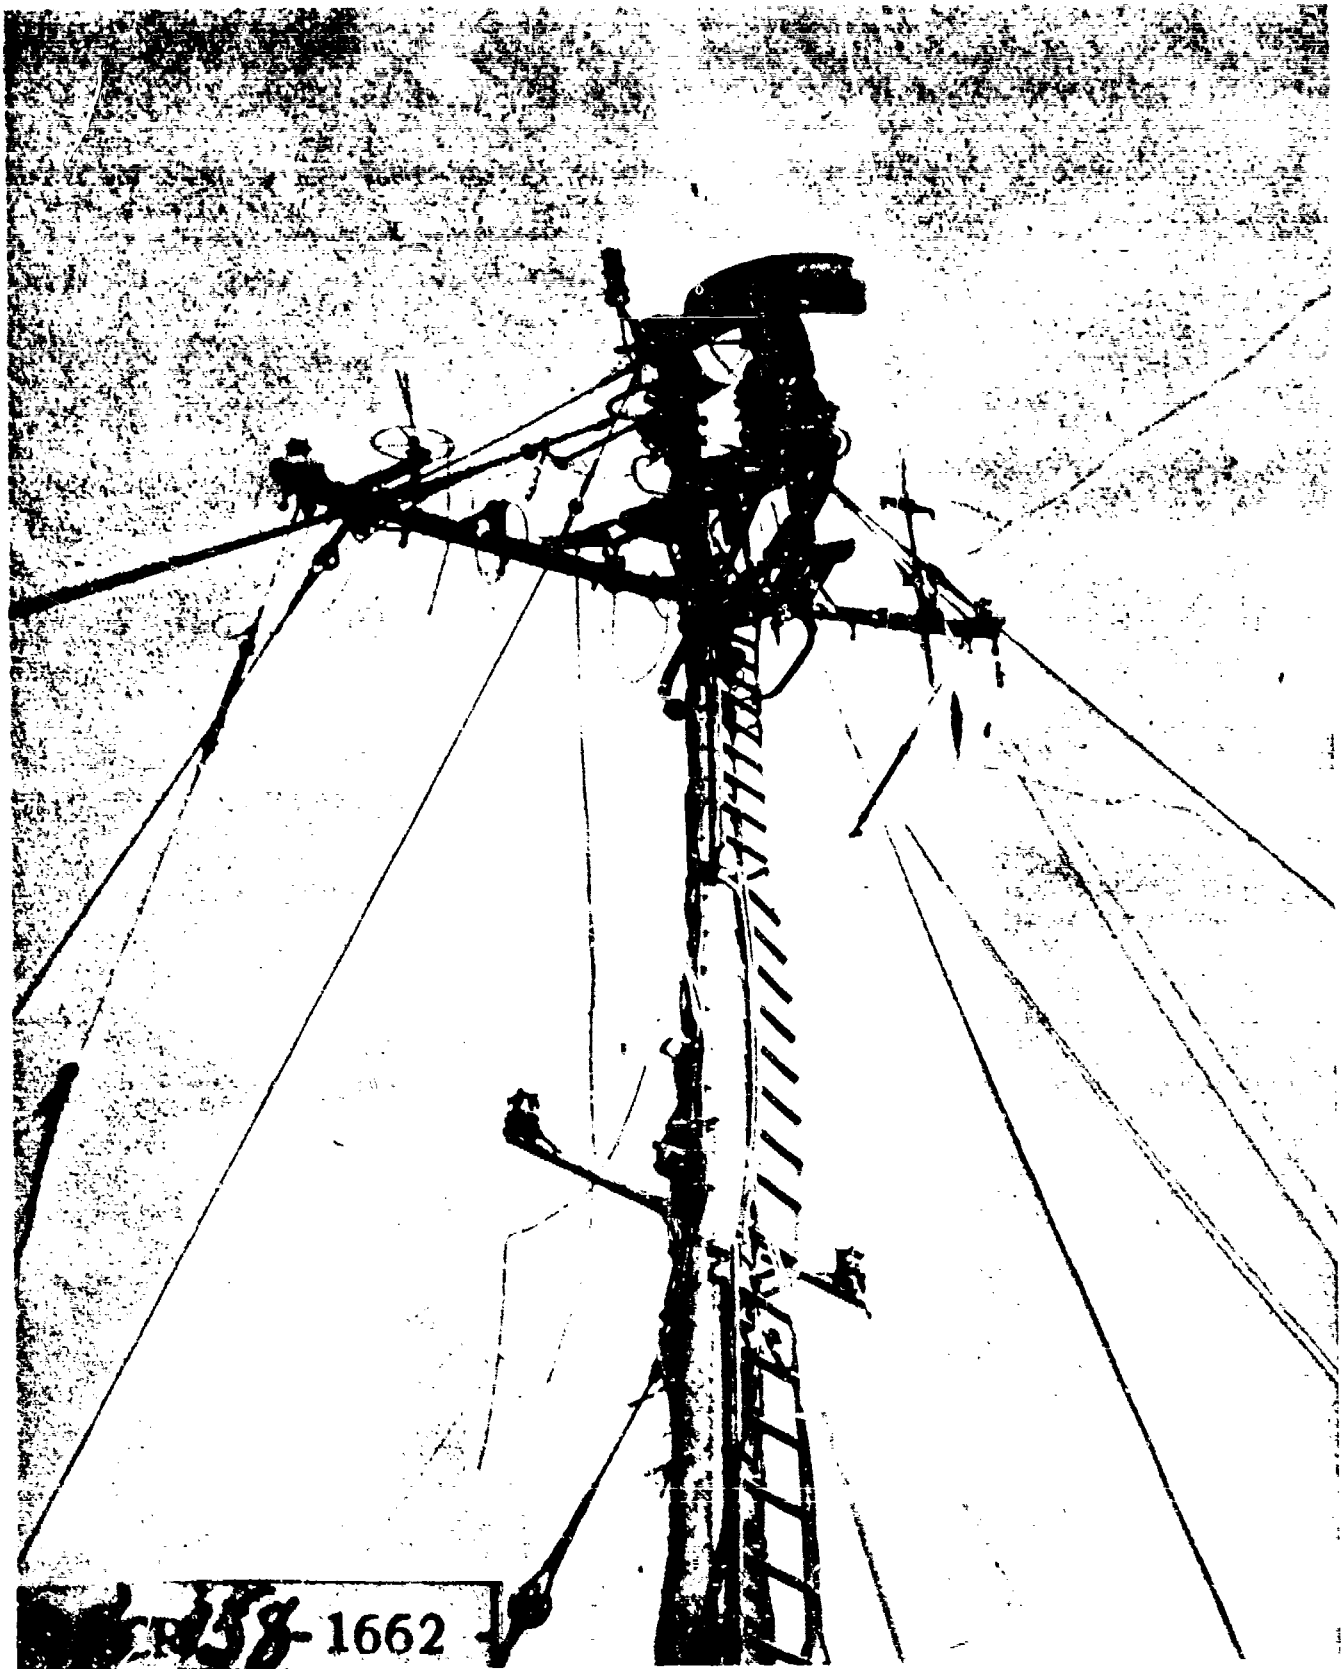
POST ABLE - MAST. View of top of mast showing the loss of SG wave guide and general damage to antenna. Mast is bent about 60° at crossarm in direction of camera.
